**CONNECTICUT RIVER BASIN
BRATTLEBORO, VERMONT**

**PLEASANT VALLEY RESERVOIR DAM
V T. 00064**

**PHASE I INSPECTION REPORT
NATIONAL DAM INSPECTION PROGRAM**

JUNE 1979

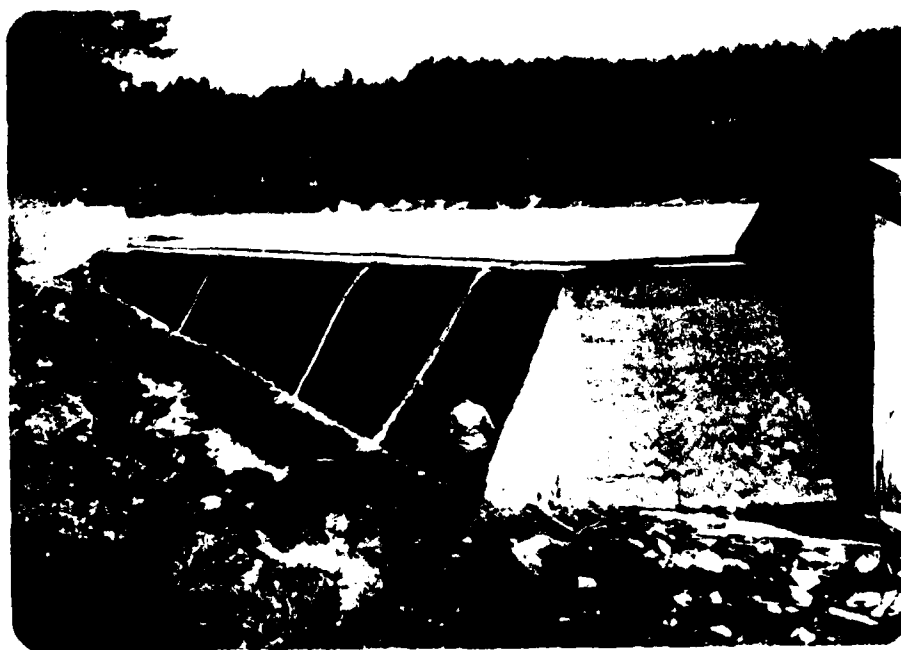
The concrete spillway (see Photo 2) located on the right abutment is 88 feet long and varies in height from 4 feet high to approximately 10 feet high. The exposed part of the upstream face of the spillway is in good condition and the joints in the concrete have been patched. The downstream face, however, has several construction joints in need of repair, as the water overtopping the spillway has eroded the sealant and the concrete at the joints has spalled as shown in Photo 1. The concrete apron immediately below the spillway has cracked and broken in several places.

#2. VIEW OF SPILLWAY AT RIGHT ABUTMENT

- a. Direct the repairs of the concrete spillway apron.
- b. Develop a plan for control and monitoring of seepage through the dam and its foundation. Discharge from the seeps should be analyzed and recorded on a regular basis for flow and suspended solids concentration. Special attention should be given during and just after a significant rainfall.
- c. Assess the capacity of the emergency spillway.

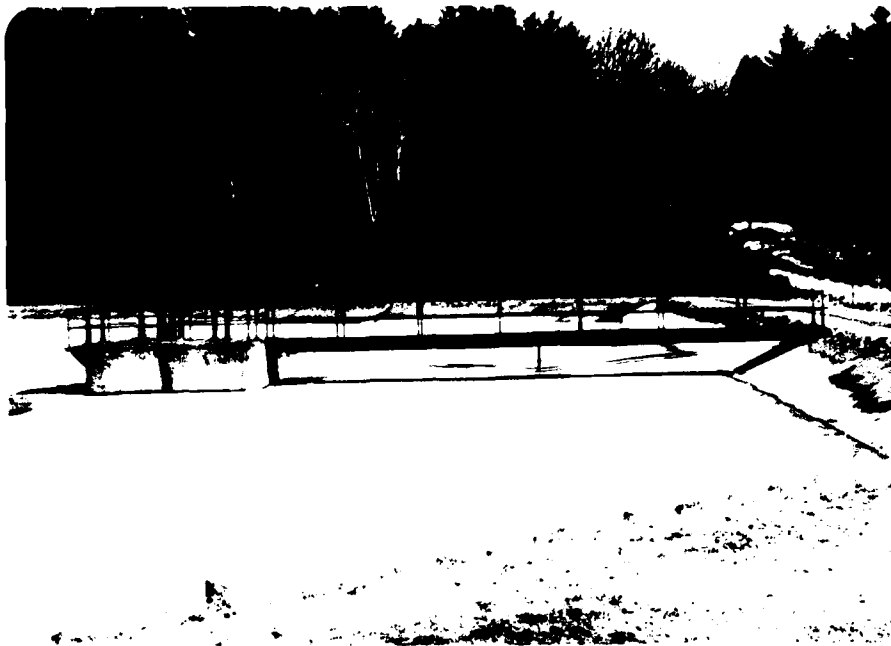
The upstream slope is protected by a concrete pavement which is in good condition as can be seen in Photos 1, 3 and 5. The concrete slab extends below the water surface to elevation 620. From that point downward along the slope is riprap. Joints in the concrete slabs have been patched with a sealant and kept in good condition.

#3. VIEW OF CONTROL TOWER AND ACCESS BRIDGE
LOOKING TOWARD LEFT ABUTMENT

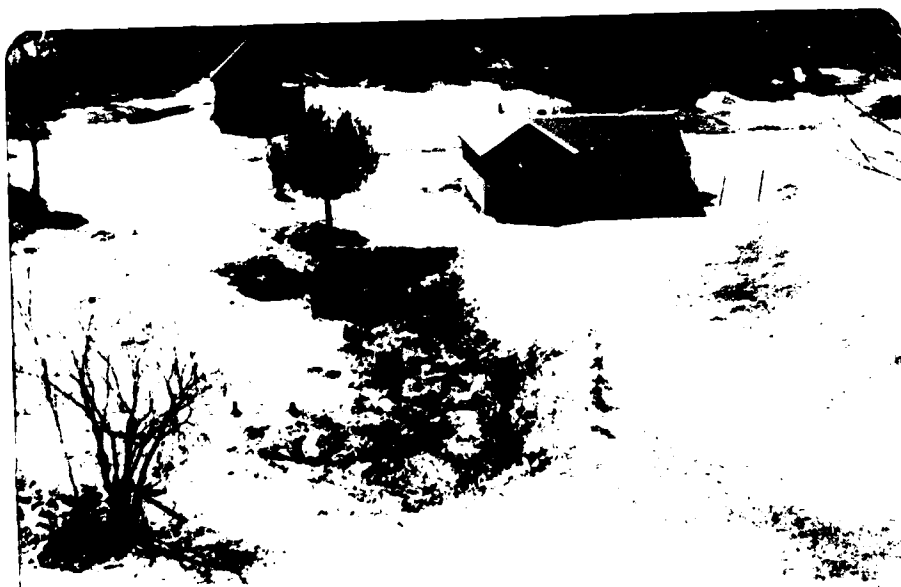
#4. VIEW OF CHLORINATION BUILDING IMMEDIATELY
DOWNSTREAM OF DAM
